Navajo Abandoned Uranium Mine

Site Screen Report

Lone Star AUM Site

March 2010

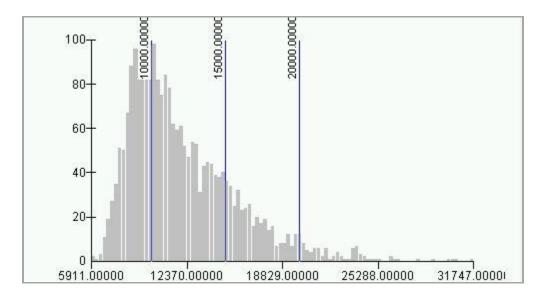
A total of 2,373 gamma radiation measurements were collected from the mine site, ranging from 5,911 cpm to 31,747 cpm. The measurements are represented in Figures 1 and 2.

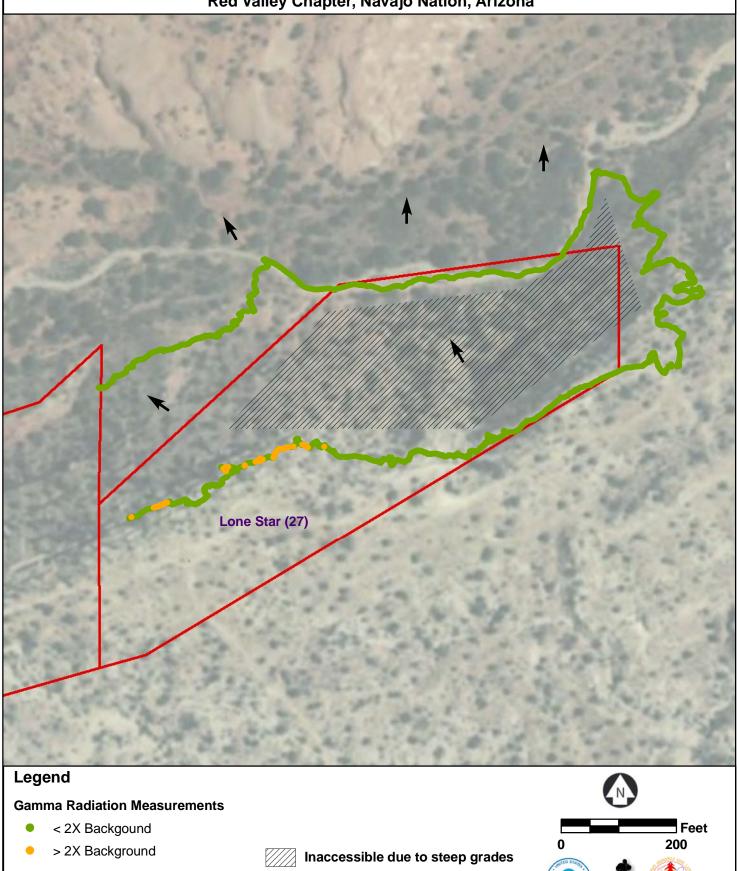
Figure 1 - Gamma Radiation Measurements, Above Two Times Background Lone Star (27) Red Valley Chapter, Navajo Nation, Arizona

Gamma survey conducted 10/2009 Measured as counts per minute (cpm)

Average background = 10,144 cpm

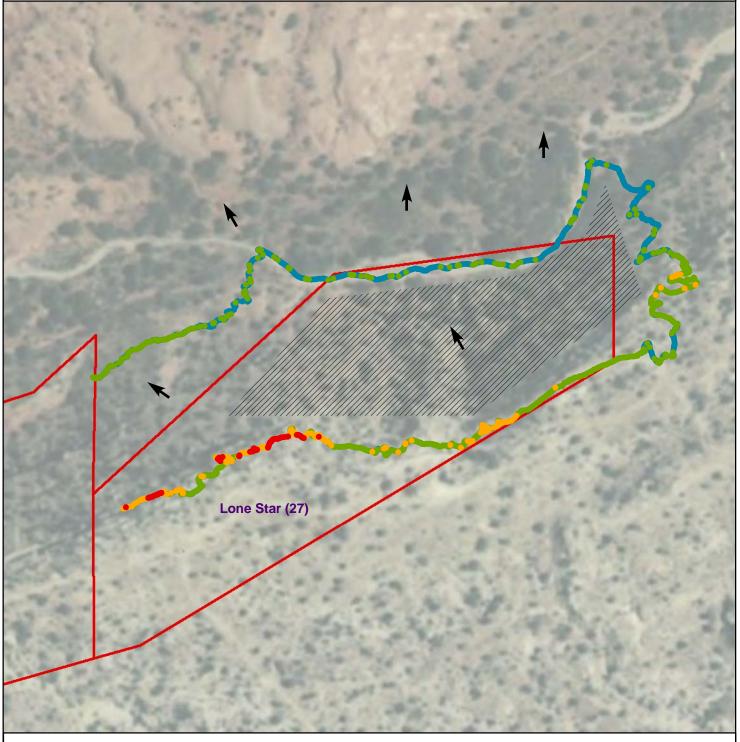
Figure 2 - Gamma Radiation Measurements Lone Star (27) Red Valley Chapter, Navajo Nation, Arizona

Gamma survey conducted 10/2009 Measured as counts per minute (cpm)

Average background 10,144 cpm
